REPAIRING VINTAGE THROUGH HOLE PCB'S WITH MINIATURE EYELETS. H. Holden (Jan, 2019).

Through hole pcb's are common in most vintage electronics. This article relates to some pcb repairs on an S-100 Computer Disk Controller card made by North Star Computers in the late 1970's, however it could apply to all through hole pcb's.

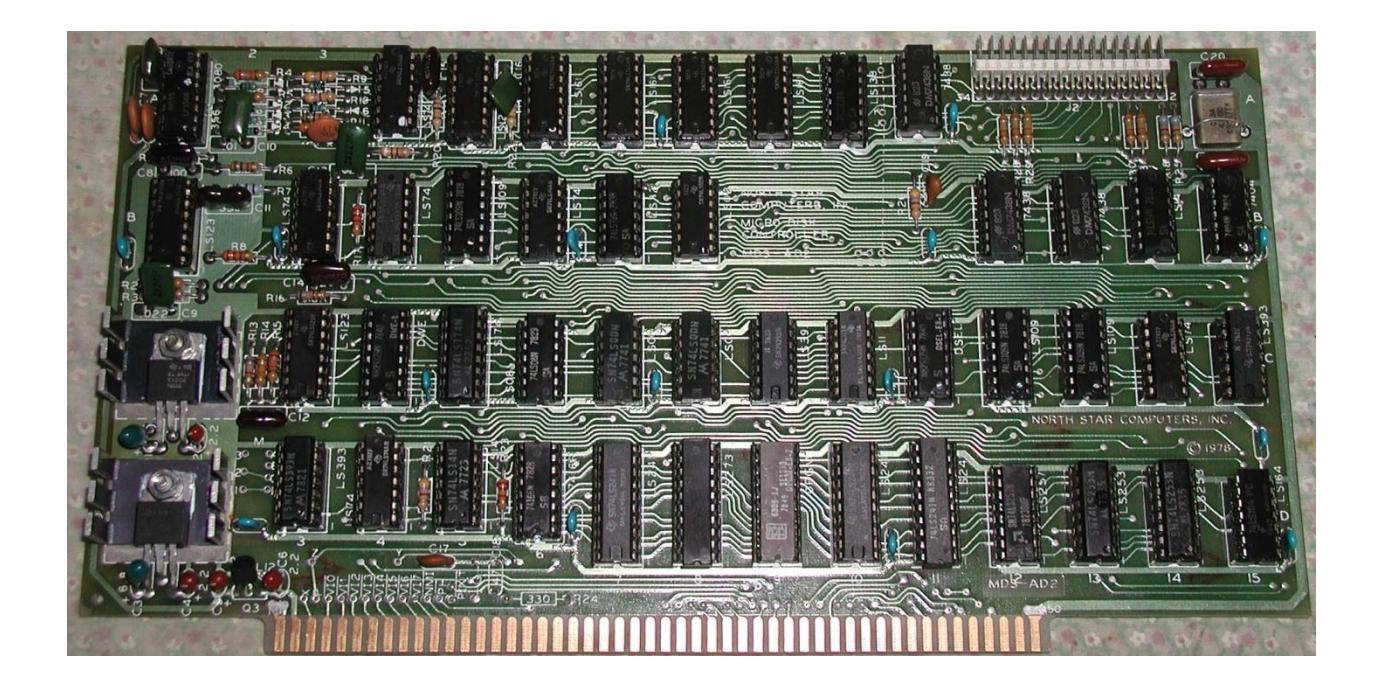
The pcb under consideration is shown below. Somebody in the past had attempted repairs and had replaced one of the IC sockets, creating track and pad damage. In addition the pads for some of the discrete components on the board had also been damaged.

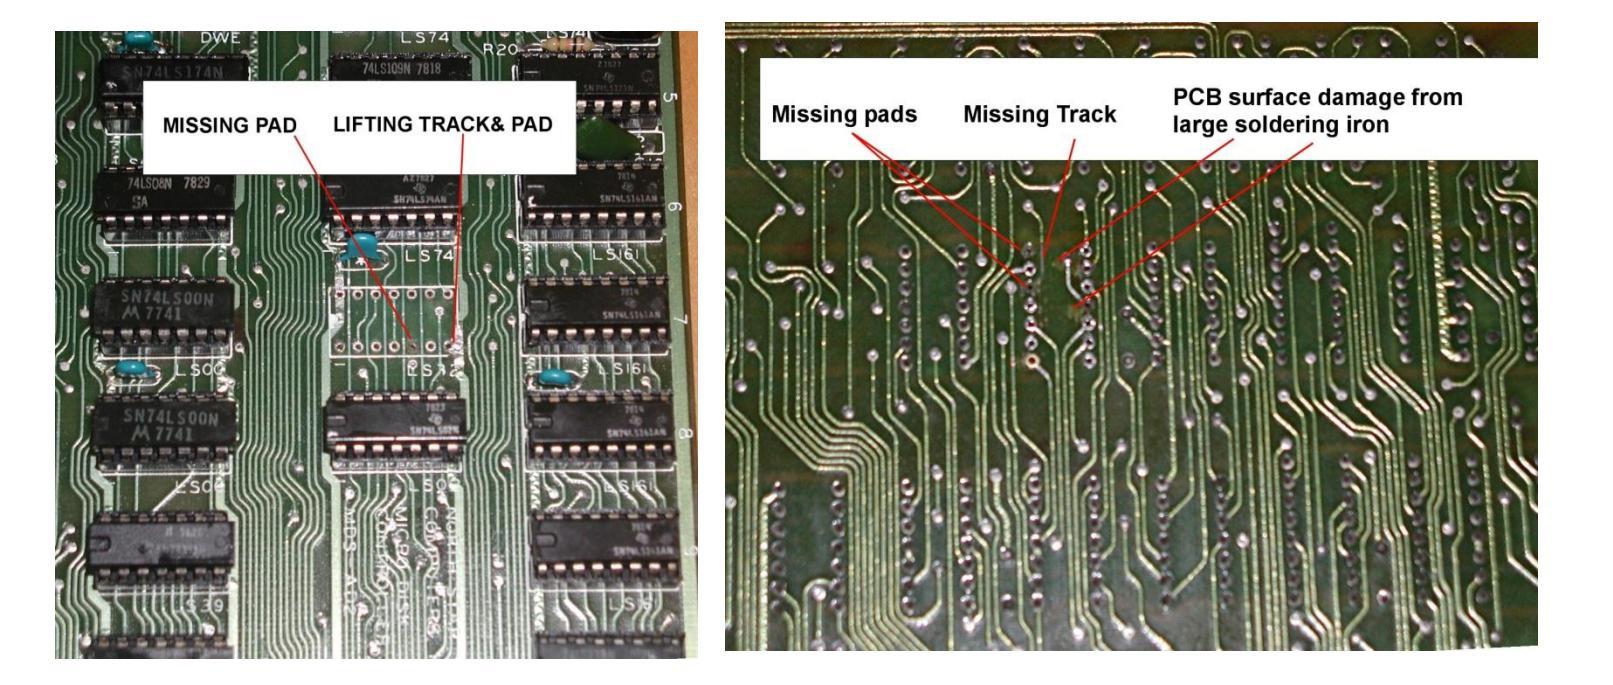
However, if a pcb is subject to repairs by the inexperienced, damage can be done which causes the pads and tracks to lift. The typical errors here include a soldering iron tip that is too large and applies too much heat because it is not temperature controlled. Or applying force to the component while heating the pad at the same time the solder is not fully melted, or the poor use of de-soldering tools and poor technique. It comes down to a combination of excessive heat & force together, that causes the tracks and pads to separate from the pcb surface.

The photo below show some of the the track and pad damage:

To tackle this damage I decided to use some miniature Eyelets. This is not a new idea but it is not commonly done. I found I could get 0.9mm OD brass eyelets (on Ebay) which were 2.5 or 3mm long (the actual eyelets measured closer to 0.95mm OD) Their ID is close to 0.6mm, suitable for a component wire. This length is measured from the end to end of the eyelet. I found that if I placed the 3mm eyelets temporarily in a 1mm diameter hole in a 2.5mm metal panel (as a length calibrator) and filed off the projecting length, it made an eyelet which was close to 2.7mm total length, which behaved perfectly for fitting to a 1.6mm thick pcb.

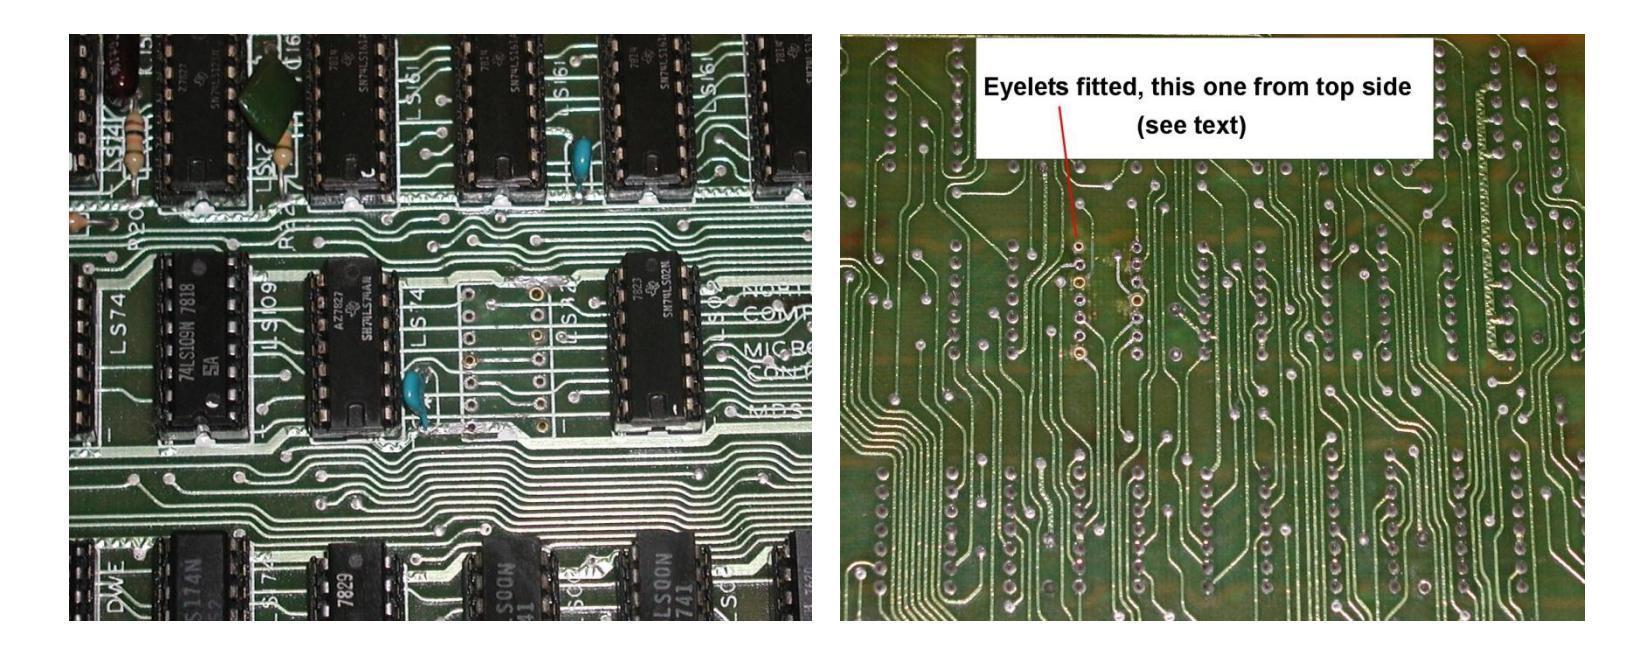
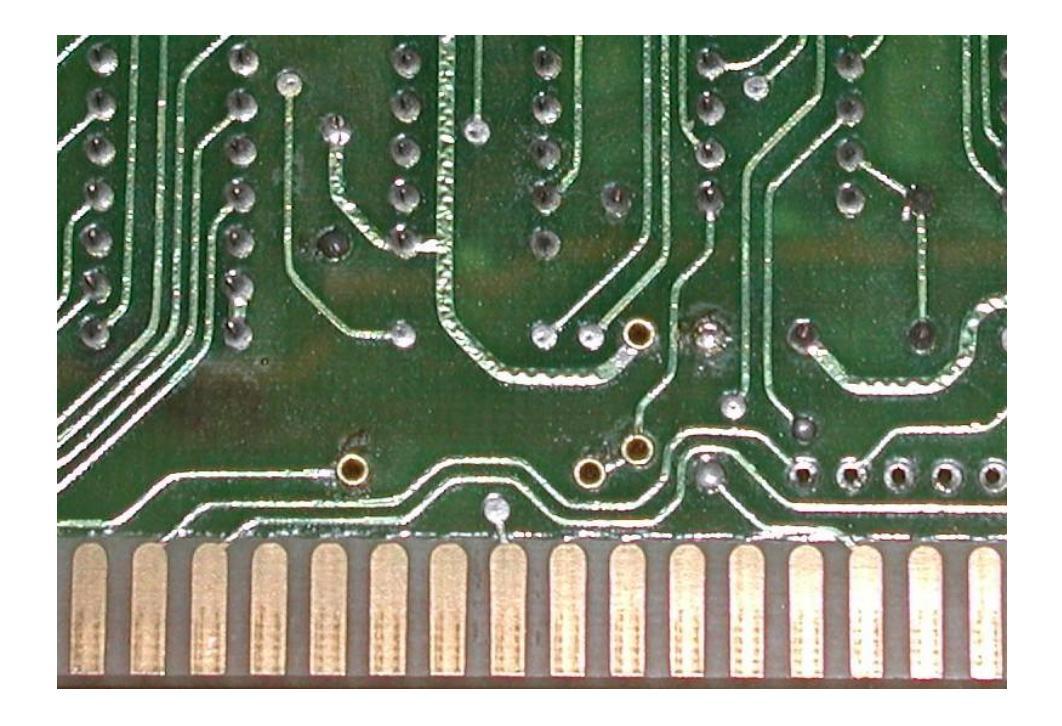
The photos below show the eyelets fitted to the damaged North Star pcb in the area of the IC sockets and in another area of previous damage:

Once the eyelets are fitted they are soldered to the adjacent pads & tracks and desoldered again with solder wick, or the sucker, ensure the brass eyelet is electrically connected to the pads and tracks on both sides.

The missing track was replaced with some thin tinned copper wire, taken from some wire wrap wire and to ameliorate the heat damage to the pcb surface in the area was painted over with some marine spar varnish.

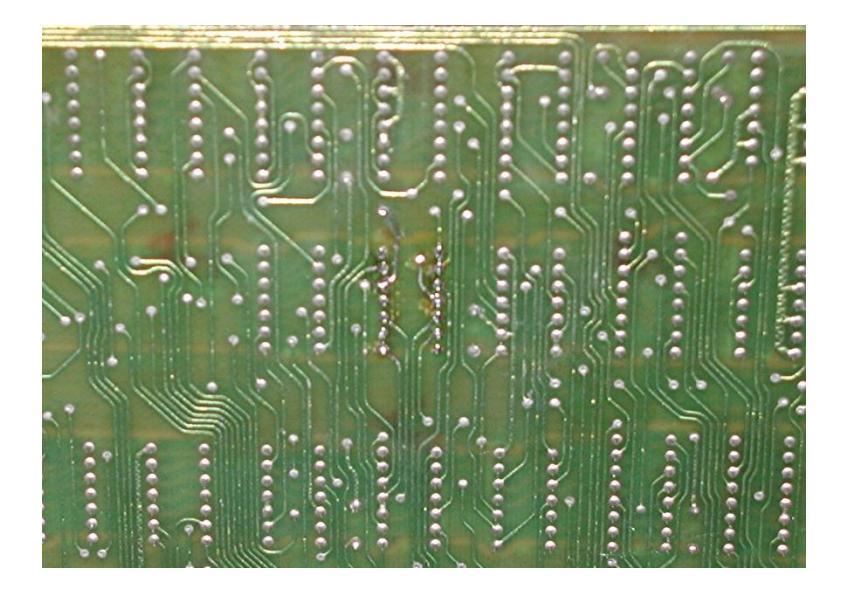
The photo below shows the repaired pcb. It looks as though the flux has not been cleaned away, this is not the case, the darkened areas are due to previous pcb thermal damage from an inappropriately large soldering iron making contact with the board surfaces:
