# RESTORING THE EARLY PET COMPUTER 9" VDU.

## LOPT (line output transformer) Testing & Analysis - EARLY PET VDU's.

( H. Holden. May, 2022)

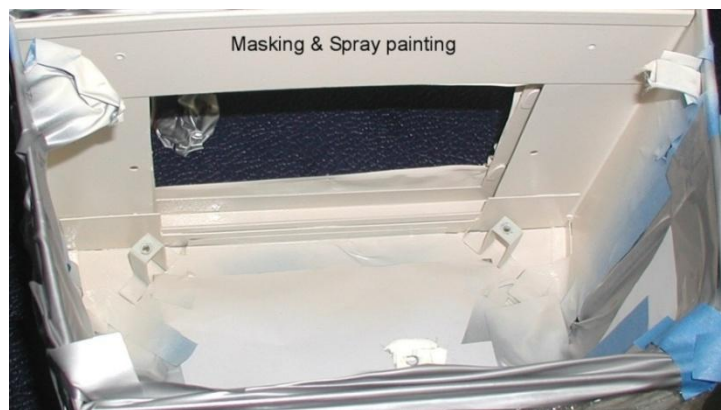
I quickly determined this was surface rust and so was the fine red dust which had been electrostatically attracted to the CRT's EHT cap. This was confirmed on a taste test that the deposits on the EHT cap were microscopic rust crystals. Rust has a very characteristic unpleasant flavour much like the haemoglobin in blood. It became evident again, where the anti-rust treatment was applied, which turns rust crystals a dark blue.

A photo shows where the rust crystals have reacted with the Fertan:

To treat rust I use Fertan organic rust converter. This is a pale yellow liquid which is convenient to brush on. It reacts aggressively with the rust and turns it into a dark blue harmless organic compound. It will also expose rust on a surface, by changing its color to blue, if it is there. Many bare or plated steel

The unaffected areas were masked and the affected areas spray painted. Because this was on the inside of the case, I simply used some stock white Duplicolor spray that was close enough. The purpose being to protect the metal from future rusting.

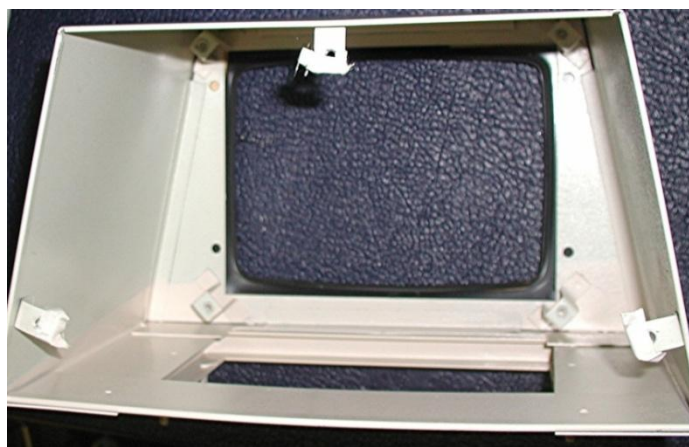
The picture above shows the completed rust repair. I'm not sure how many other PET VDU's would have this problem. It may have been unique to mine due to the poor internal spray painting. Some VDU's may require a complete repaint. In all cases if any rusting is detected it should be treated with Fertan and not just painted over, or the rust will return.

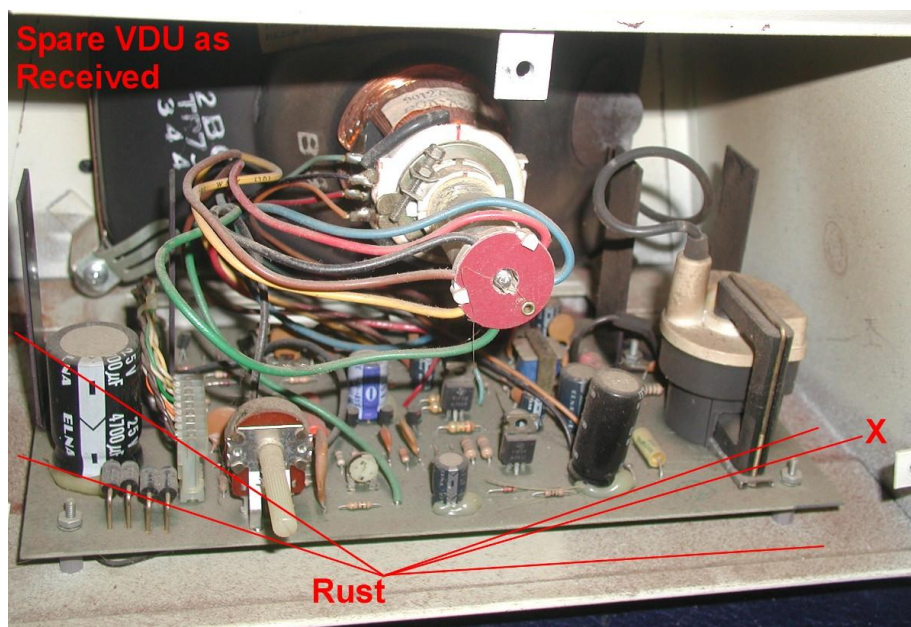
A seller on ebay had parted out a PET and was selling the VDU on its own. So I bought it with view to performing an identical restoration as my first one. The cabinet was in much poorer order though and suffered from identical rust problems as the first, but much more severe.

In general, the problem is with the paint. Due to its textured thicker nature and the fact that the cabinet insides only got a cursory spray and the spay gun was not angled to get the spray around the CRT's mounting brackets and into corners. The metal was exposed in a myriad of small areas or pits in the paint. Obvious surface rust in the area marked B, but the pits are equally as sinister, marked X. When it comes to rust there is more there, always, than meets the eye.

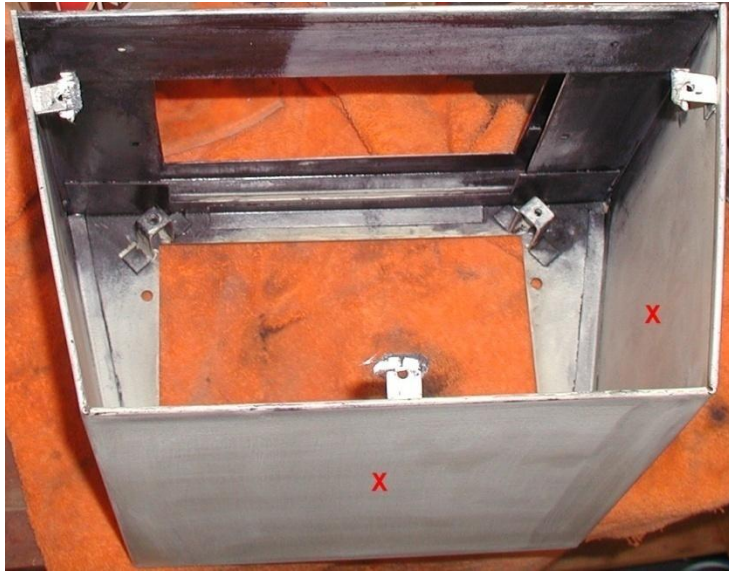
The Organic rust converter, Fertan, is like a forensic rust detector. If it is applied to rust free steel it remains a pale yellow-brown color, or applied to plastics or paint. Any microscopic rust at all it turns a blue black. After cleaning off the surface scale and applying it to the PET VDU case (including the painted areas inside & out) showed where the rust was, and it is much more extensive than it looked.

When the Fertan was applied to the paint, both inside and outside of the cabinet it unmasked multiple points of rusting in the pores of the paint. Even the outside the paint layer on this VDU did not provide perfect rust protection.

Therefore, before re-painting one of these VDU's it is important to deactivate all the rust crystals by applying Fertan everywhere, even over the paint. When it is dry (it is water based ) a soft moist cloth can be used to wipe off the excess before preparing the surface for painting.

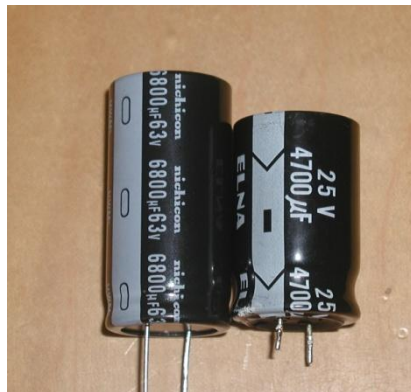
The main power supply filter capacitor, prior to the regulator C1 is a 4700uF 25V type. In my VDU, to acquire a capacitor of the same lead pitch to fit snugly on the pcb, I replaced it with a 6800uF 63V type, RS part 739-5386. The photo below shows the new part is a little taller, but there is plenty of room for that.

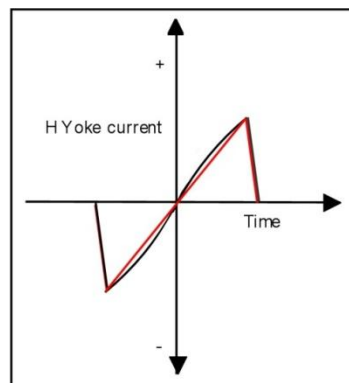
This is shown diagrammatically below, where the Red line would indicate a perfect sawtooth current wave and the black line the effect of the S correction capacitor on the Horizontal yoke coil's current waveform.

The rate of change of current with time has increased in the mid horizontal scan area, near the screen centre and decreased on either side, on the left and right side of the scan.

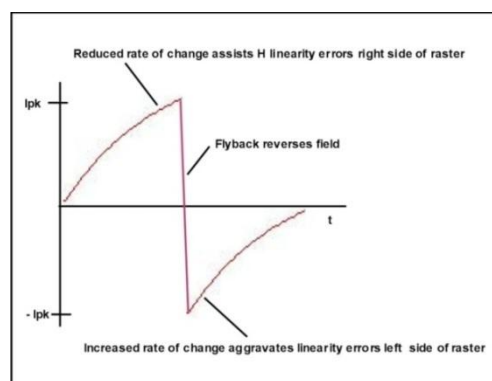
This is shown, exaggerated to make the point in the following diagram.

Some of the higher rate of change of current with time at the start of the scan on the left side is improved with S correction, but it is not enough at the point where the S correction is correct for the centre of the scan and right hand side of the scan at the same time.

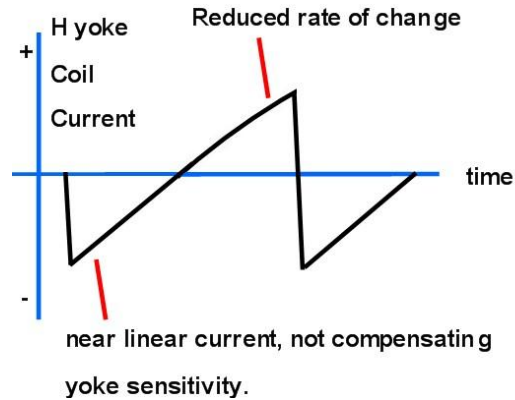
Therefore, inspection of the current wave in the H yoke coils in nearly all TV sets & VDU's, that just have the S correction capacitor and no magnetic linearity coil show an H yoke current waveform very similar to this:

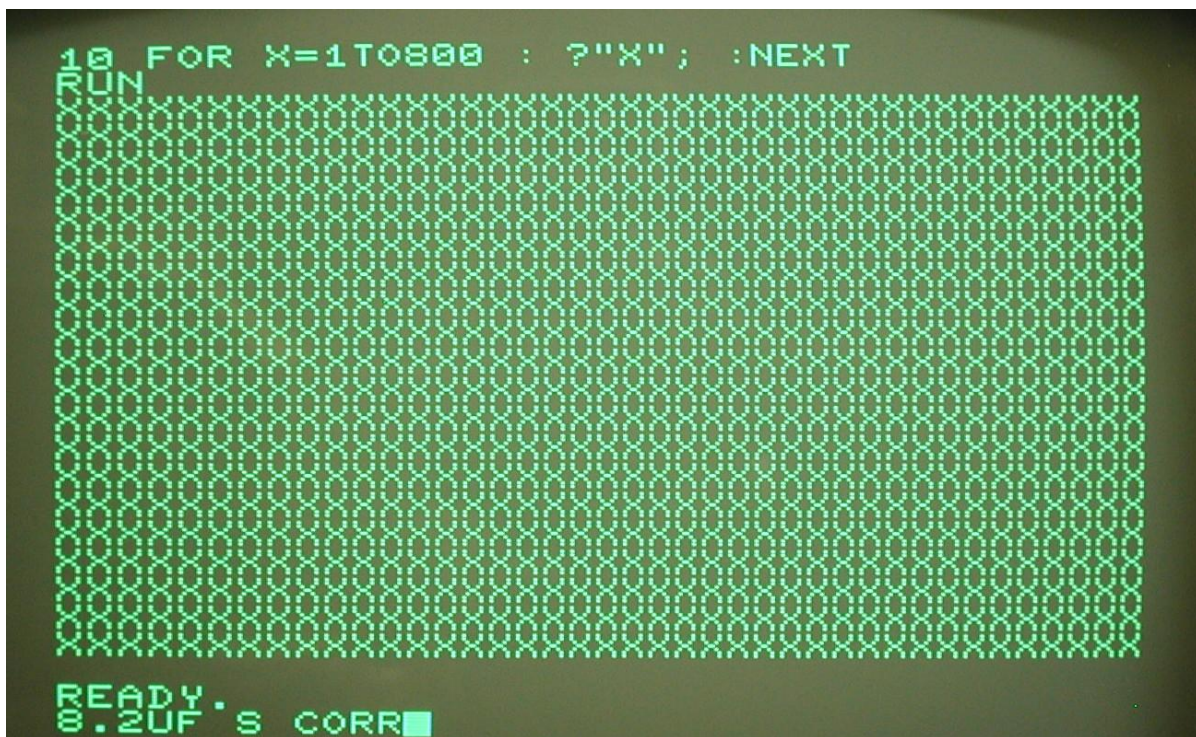
With the 8uF in place in the PET VDU, instead of the original 10uF and this time plotting X's to compare their widths, the central and right side linearity is now a near perfect match and the "S" correction spot on:

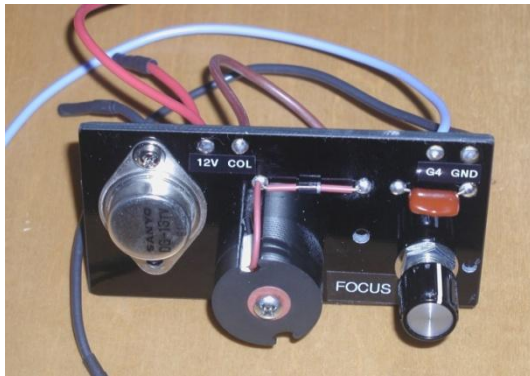
The peak voltage across the ERD is close to 110V in use, the 120V zener is not conducting. If the horizontal drive frequency drops though more energy is stored in the yoke & LOPT per cycle and the peak voltage could potentially near double, so the 120V Zener diode clamps it off to a safe value, protecting both the HOT, the LOPT and the EHT rectifier inside the LOPT body. The photo below shows the board assembly. I simply made it on a 1/8" fibreglass plate with 2.3 mm diameter silver plated brass eyelets, but a standard pcb would be just fine. I made one for each of my VDU's:

The spacers can both be metal, because the body of the DG13tv (or other rectifier types cited) is connected to ground. No insulators are required for the TO-3 cased diode. The TO-3 diode barely warms up in use, certainly less to than the original small 1N4935 glass diode it is shunting. Because the forward voltage drop of the DG-13 diode is so low, even though the 1N4935 is still there, it does not conduct any current.

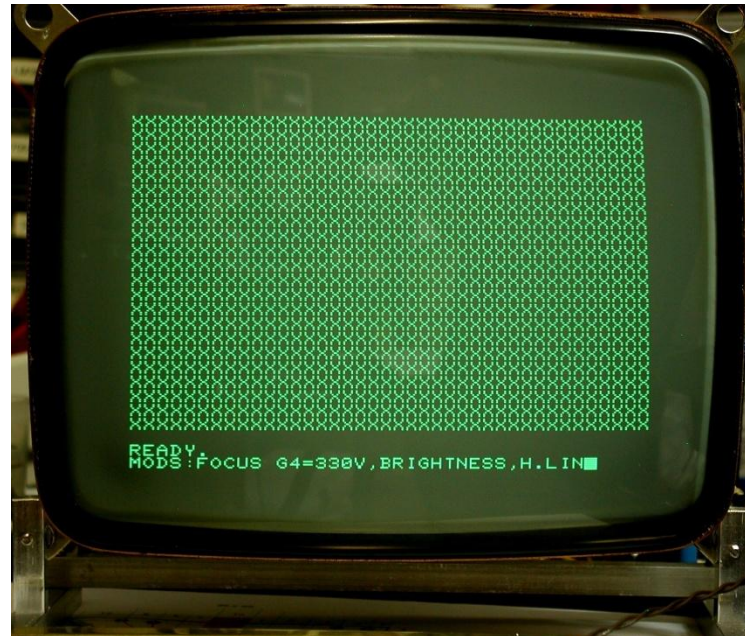
Overall result with Focus & Linearity mods in place shown above. The overall H scan linearity is quite good with just a very small trace of remaining left sided stretch (thanks to the Germanium ERD). The centre and corner CRT beam focus is good.

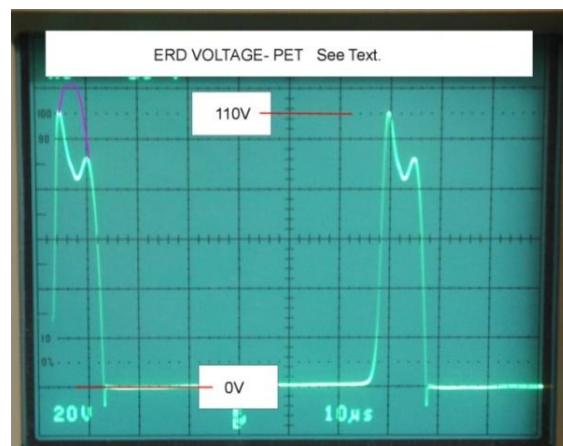
The Flyback pulse's base represents half the period of the low frequency resonance and the dimple in the top of the pulse represents the high frequency resonance. (The purple line drawn on the recording would be the shape if there was no high frequency resonance superimposed)

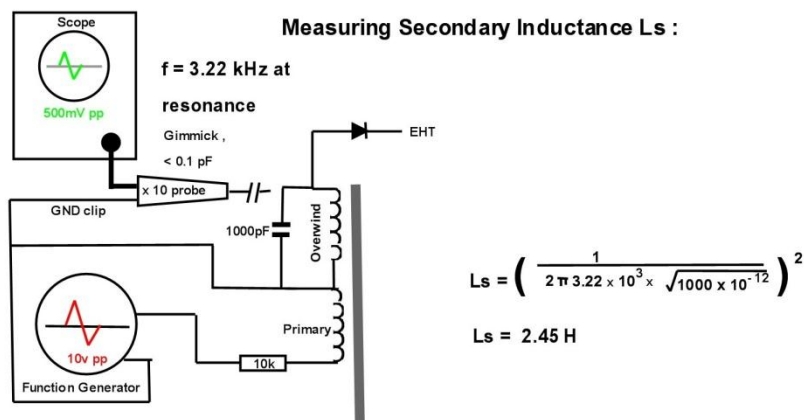
The scope probe is merely placed near the overwind output wire to create a small “gimmick” coupling capacitor. Generally, the Overwind’s self capacitance is around 7 to 8 pF. This is swamped by adding a 1000pF capacitor to down tune the resonant frequency to the range of 3.2kHz. In the example transformer tested, the Overwind’s inductance is calculated at 2.45 Henries.

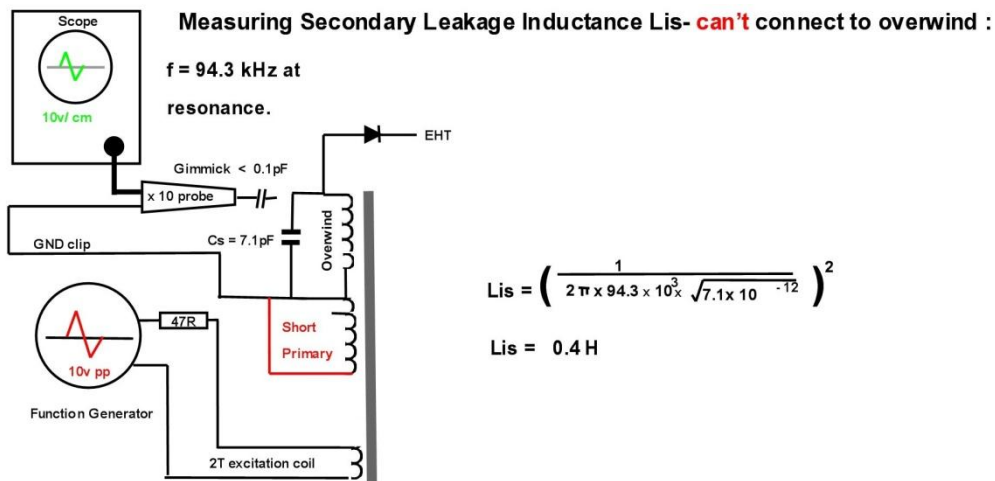
Likewise the secondary leakage inductance (and hence the  $k$  value) can be estimated if the self capacitance of the Overwind is estimated to be in the region of 7pF:
