THE MEISSNER 5 INCH KIT AND THE ANDREA KTE-5:

Dr. Hugo Holden 2012.

Restoration of The 5" Meissner TV KIT

Restoration of an Andrea KTE-5 Kitset

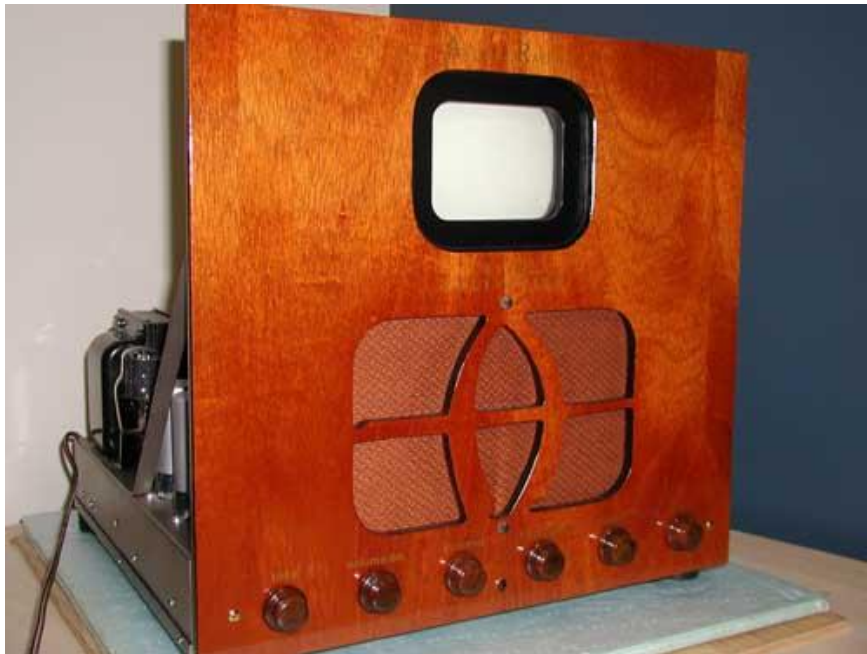
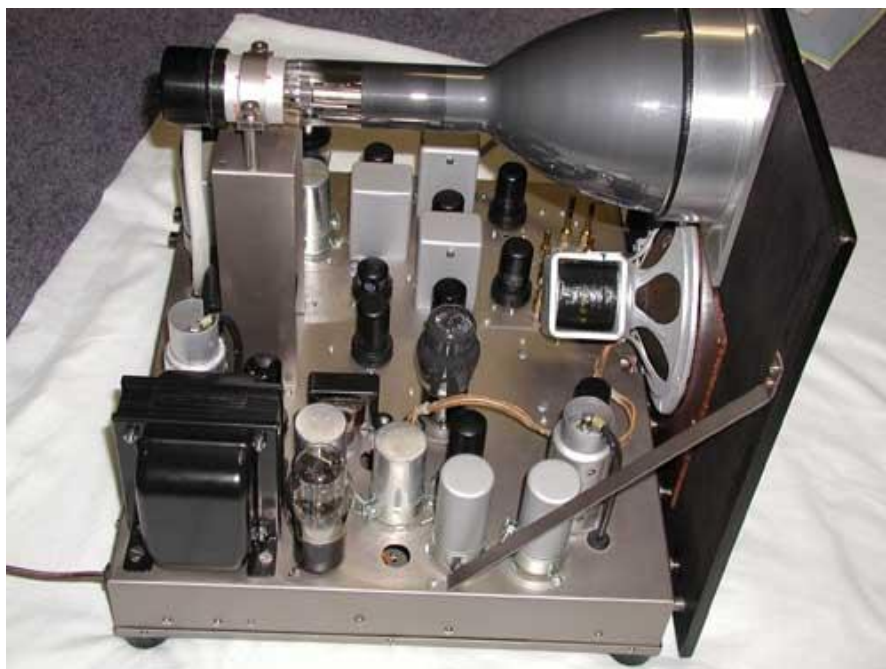
ANDREA KTE-5:

Photos of the restored sets which I restored over 10 years ago:

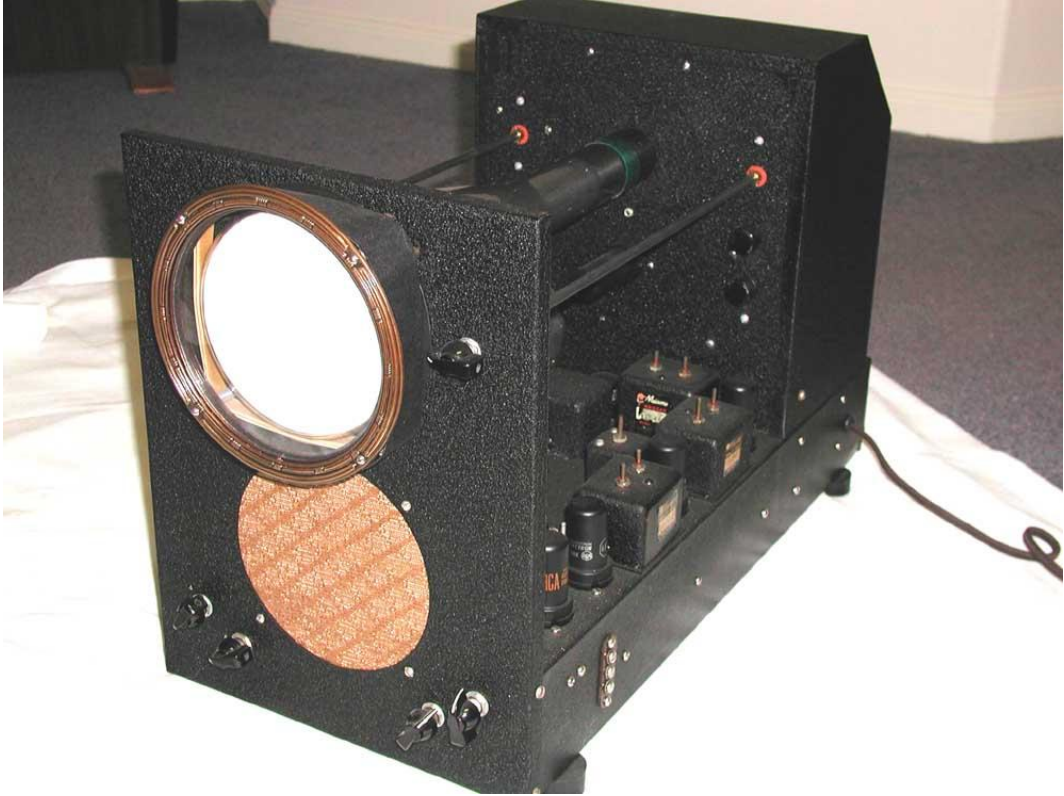
MEISSNER Model 10-1153

The Meissner set in the photo above is fitted with a late 1950's manufacture RCA 5BP4 which has excellent emission. The Andrea is fitted with a new old stock 5AP4. The KTE-5 also came as a pre-built factory version with a full cabinet called a model 1-F-5. Meissner also had a full cabinet available with an art deco look to it:
