BUSH TV22 RESTORATION. (Dr. H. Holden.)

Update 2020:

1) PHYSICAL RESTORATION OF THE LOPT.....	Pg. 2
2) LOPT VOLTAGE ANALYSIS.....	Pg. 5
3) LOPT TURNS & INDUCTANCES & RECORDINGS VS CALCULATIONS.....	Pg. 6
4) EHT VOLTAGE MEASUREMENTS & CALCULATIONS.....	Pg. 10
5) OVERWIND SELF CAPACITANCE & RESONANT FREQUENCY.....	Pg. 14
6) EY51 HEATER WINDING.....	Pg. 15
7) LINEARITY CONTROL.....	Pg. 17
8) SCOPE RECORDINGS LOPT PINS 1 TO 6.....	Pg. 18
9) THE METROSIL.....	Pg. 19
10) GRID DRIVE VOLTAGE PL38.....	Pg. 20
11) CATHODE CURRENT PL38.....	Pg. 21
12) LINE (HORIZONTAL COILS) YOKE CURRENT.....	Pg. 22
13) PZ30 DAMPER DIODE A-K VOLTAGE RECORDING.....	Pg. 23
14) IMPROVING THE TV22's INTERLACE	Pg. 25
15) THE 470pF LOPT TUNING CAPACITOR.....	Pg. 30
15) RESTORATION OF THE TV22.....	Pg. 31

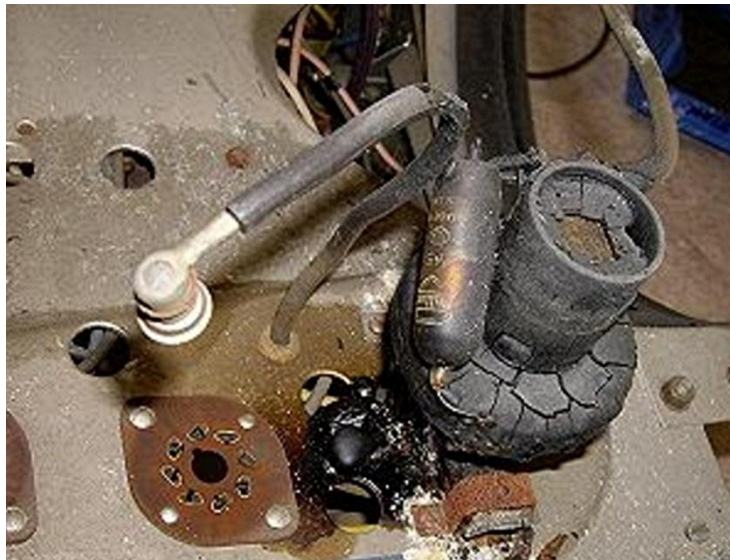
The photo below shows a typical TV22 LOPT in an untouched set (This photo was provided by Steve Ostler, thank you Steve). This is the way a typical TV22 LOPT looks in the year 2010 + and exactly the way it was in my TV22 before I treated it.

The reason it looks like this is that pitch (tar) contains a range of molecular weight hydrocarbons. With age, the lower molecular weight ones evaporate. So the material becomes brittle (less fluid) and the volume of it decreases. Therefore cracks appear as the material volume shrinks. These cracks extend down to the surface of the EHT overwind and allow moisture in and compromise the insulation. Still, despite this, many TV22 owners are so enthusiastic to power their sets (often to see if the CRT has emission) that the risk of powering a LOPT in this compromised condition gets ignored.

Unfortunately, pitch of this age and dryness is very resistant to melting again so attempts to heat the pitch, to melt it off, are fraught with hazards and the remaining pitch gets baked on. In addition physically picking at it damages the underlying wiring, especially on the fragile EHT over-wind.

Fortunately the solution is to put the whole transformer in a bath of mineral turpentine (or white spirits in the UK) and the pitch slowly dissolves away in a few days. This also has a joint effect of not having to run any current via the over-wind to heat it, the turpentine solvent drives out and displaces the moisture. I learnt about mineral turpentine dissolving pitch as a teenager, where I used it to dissolve the pitch off the top of tar topped car batteries.

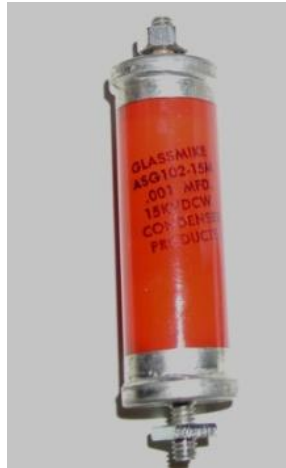
This capacitor (shown below) also has an acrylic top cover added to prevent corona discharges. It was screwed into an existing hole, where the anode wire for the PL38 previously passed through.

The anode wire for the PL38 was replaced with 25kV capable EHT cable, so that it could pass through another pre-existing hole without a rubber grommet.

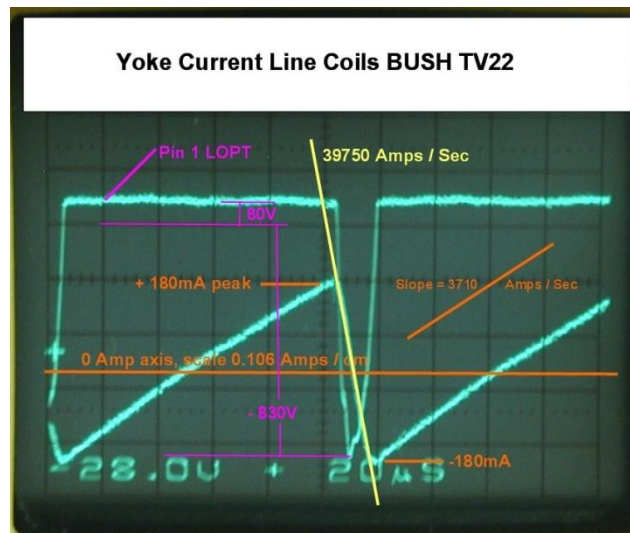
A recording was made of the yoke current (see below how this was done) which is the LOPT's secondary current. For now the important piece of information is the peak rate of change of current with time, dI/dt , in the H yoke coils of about 39750 amps per second during flyback. This is also the current for the LOPT secondary (ignoring the effect of the shunt winding of the width coil)

On account of the approximate load inductance of 21mH, the H yoke coils and the width control inductor, the flyback voltage on the secondary coil pin 1 of the LOPT is close to $39750 \times 21\text{mH} = 834\text{V}$. (830 peak approx by measurement, pin 1 of LOPT).

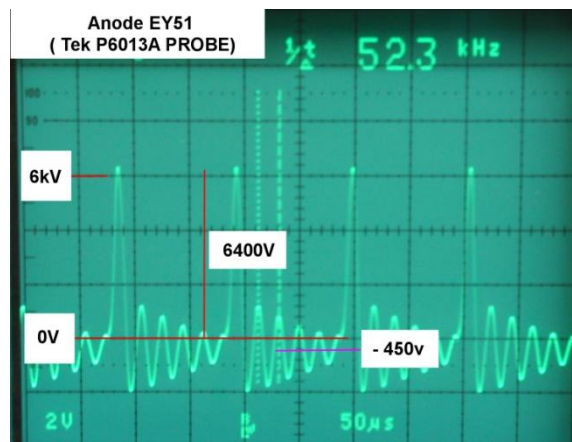
Therefore, to establish the basic transformation ratio of voltages between the windings, it is probably better to look at the measured voltages during scan time where the LOPT is operating in "transformer mode". This would mean the measurement of the overwind voltage and the loading by the probe for that measurement had much less effect on it, especially since the voltage is much lower and the current drawn by the probe much less than on the very high peak voltage that produces the EHT.

Ignoring the oscillations during scan time caused by the leakage inductance of the overwind (see below) the average voltage seen in the recording above is close to - 450V. Notice the EHT is loaded down to 6400v by the 100M ohm resistance of the Tek P6013A probe, versus the 1000M Fluke probe that measured the EHT at 7600V on the EY51 cathode.

Therefore the voltage ratio of the overwind to the secondary, during scan time is $450/80 = 5.625$.

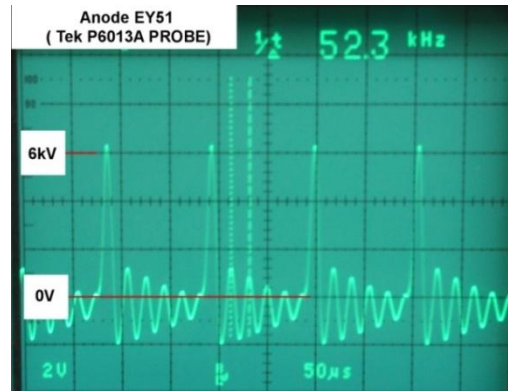
This frequency of the LOPT's tuned secondary (loaded with the yoke & width coil) is about 35.5 kHz, while the overwind "apparent resonant frequency" is higher around 52kHz. The voltage on the Anode of the EY51, with respect to the chassis, was recorded, the vertical scale is 2kV / cm:

The measured peak is around 6.4kV being lower under test with the 3pF and 100M loading from the Tek probe, compared to the Fluke 1000M probe which gave 7.6kV at the cathode of the EY51 rectifier.

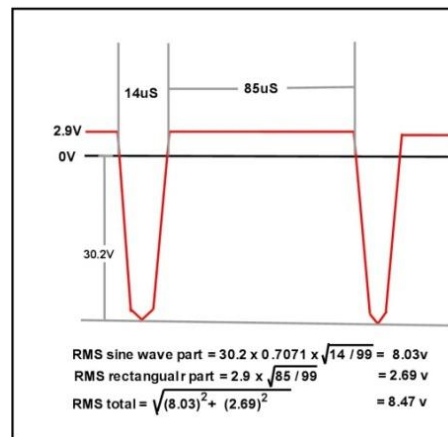
Therefore with 25 turns as an example, the scan time voltage in a 25turn winding is $(25/690) \times 80 = 2.9\text{v}$. And therefore the peak voltage, during flyback is $2.9 \times 10.4 = 30.2\text{V}$. The calculations below show the rms voltage generated by 25 un-loaded turns. This transpires to be about 8.47V, which agrees with the very rough estimate of around 8.2V in the unloaded state that the winding should likely produce:

Once again, the calculations help confirm what might be expected. However unwinding (or just counting) this winding would give exact turns numbers.

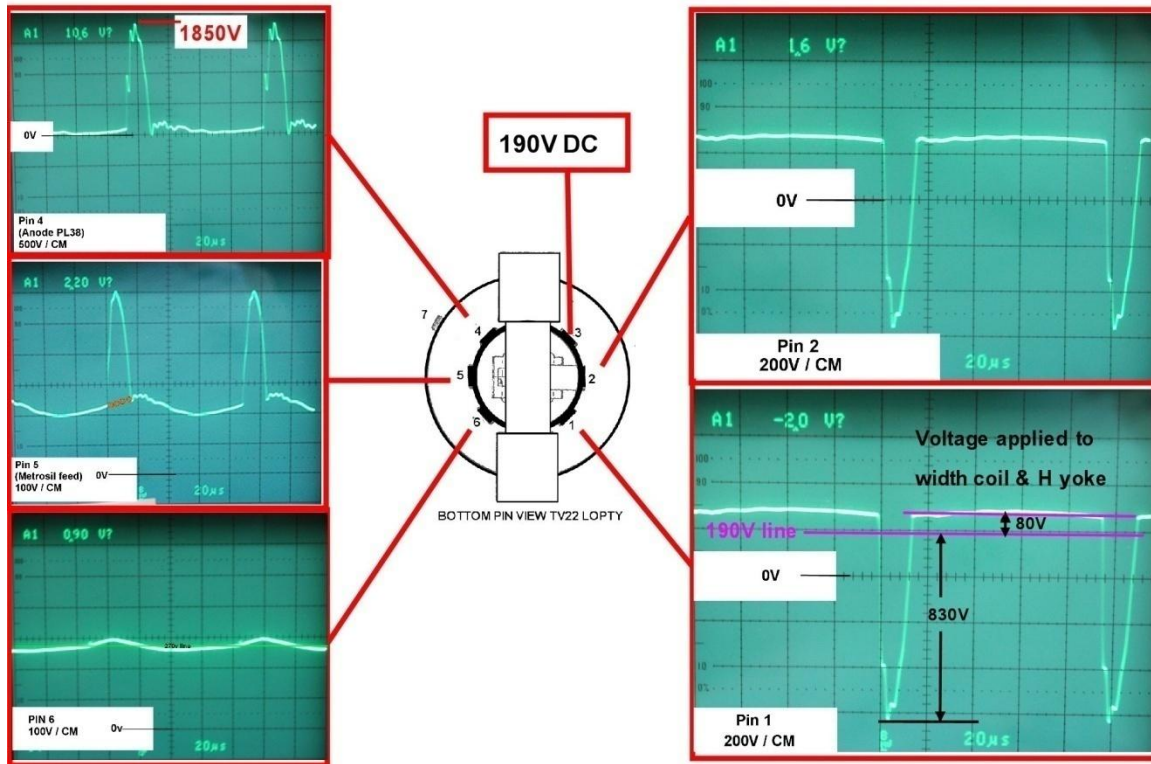
RECORDINGS, LOPT PINS:

I have made the following recordings. The pin numbers, of the lopt, viewed from below, pins 1 to 6 are in a non customary anti-clockwise direction:

The recording on pin 5, shows the voltage presented to the Metrosil is similar to the linearity correction voltage added to the boost voltage but with a flyback pulse superimposed or riding on it, above the level of the orange dots added to the recording.

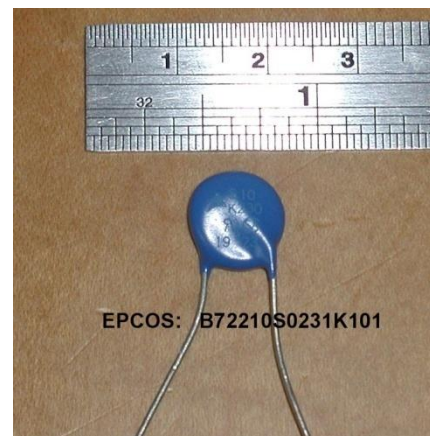
Two replacement options:

In the past some TV22 owners have replaced the Metrosil with a diode and a resistive divider. This requires a connection to ground. Experiments indicated it was possible to replace the Metrosil with another "Two Terminal Device" composed of a diode and two resistors, this configuration produces 300V which drops down by -30V with a 100Meg Ohm load, less than the 50V drop with the Metrosil and a 100M load, so it results in a slightly "stiffer" 300V supply, though this aspect is somewhat academic, as the CRT's A1 current is very low.

I tried a number of modern MOV's (Metal oxide varistors) in the application. There is a voltage range where it can be too high or too low (off load) then under an additional load a different voltage. The closest one I could find as a replacement was the MOV by EPCOS part: B72210S0231K101.

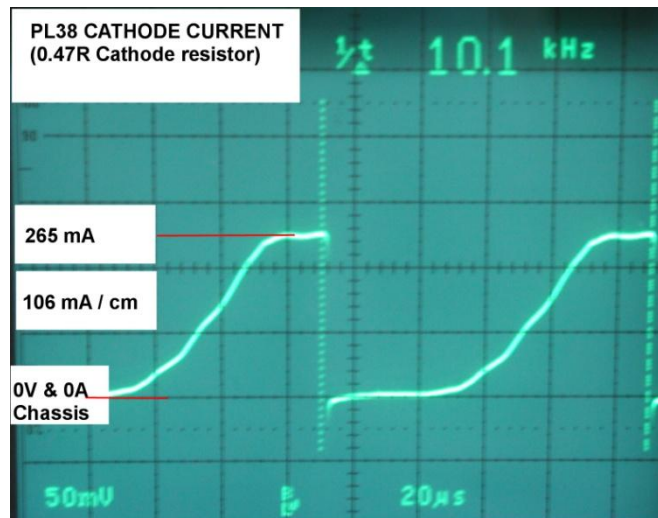
The recording shows the cathode current and as can be seen it levels over the last 20uS or so of the H scan where the PL38 is drawing g1 grid current and is in a saturated state:

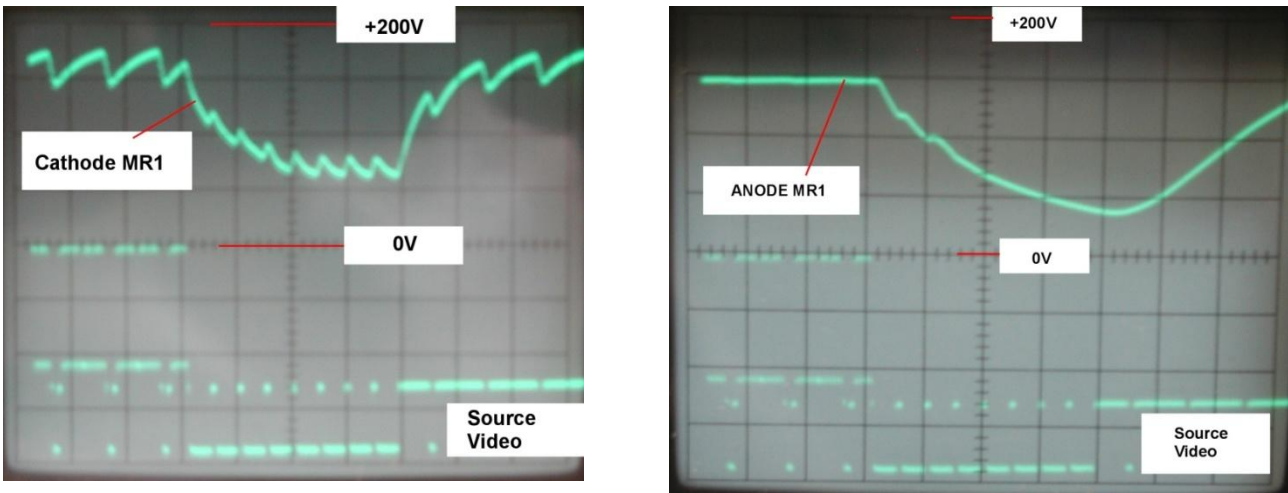
FIGURE 1.

My TV22 was set for a normal contrast image and the vertical hold set so the picture was rolling upwards just a little before it fell into vertical lock. (This is generally the better way to set a vertical hold control). Oscilloscope recordings were made of the following test points:

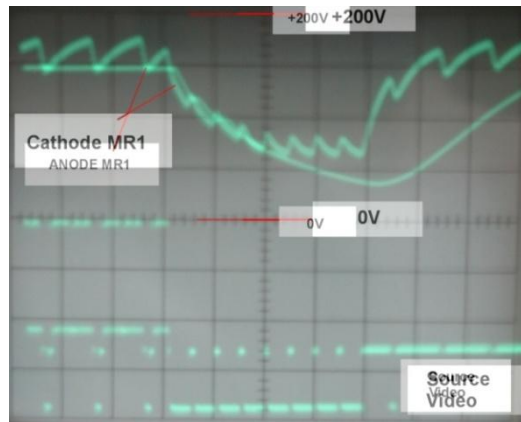
Another recording of the two super-imposed:

This shows that the diode starts conducting in the forward current mode only on the leading edge of the vertical sync.

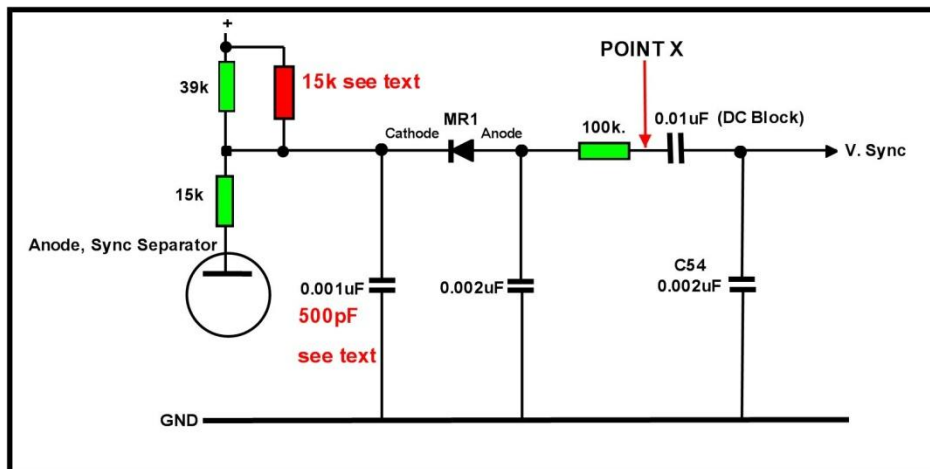
The circuit is shown below. For it to work, MR1 must be a leaky diode, if it is replaced with a modern silicon type it requires a 1 to 2 Meg Ohm resistor in parallel with it for the circuit to work.

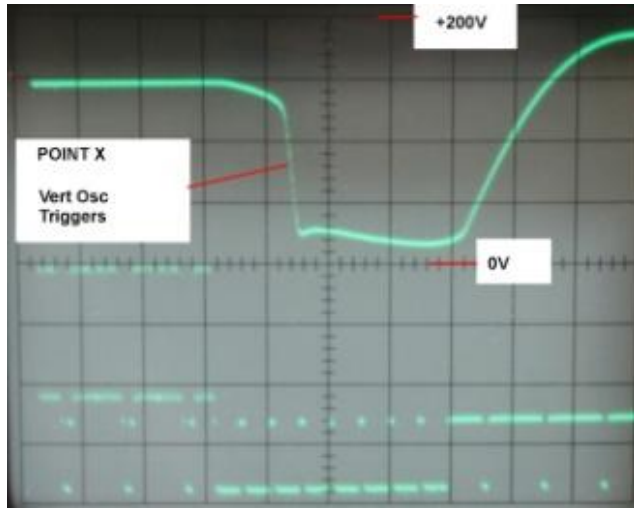
The recording at point X in the circuit is shown below:

Of note, the sudden negative going transient seen above at “Point X” is the result of the vertical blocking oscillator’s plate voltage falling low (vertical flyback initiated) after being triggered by the vertical sync pulse. The blocking oscillator transforms the negative going sync pulse injected at the plate to a positive voltage at the grid, to synchronize the V oscillator.

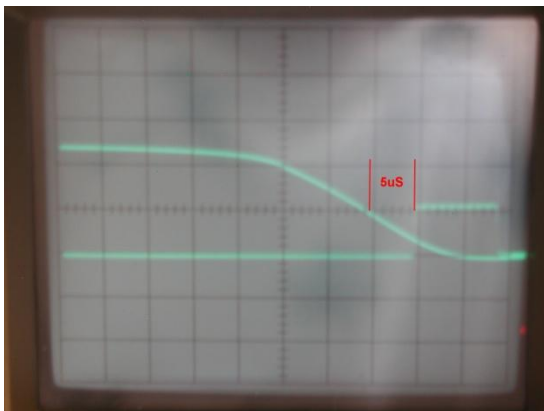
Close examination shows a timing error, which creates a 4uS or 9% interlace error. (Of note a 100% interlace error would be half a line period or 49us) These recordings show the timing of the vertical sync pulse leading edge with respect to an H pulse inside the vertical sync pulse, comparing odd & even fields:

As can be seen there is roughly a 4uS error in the timing.

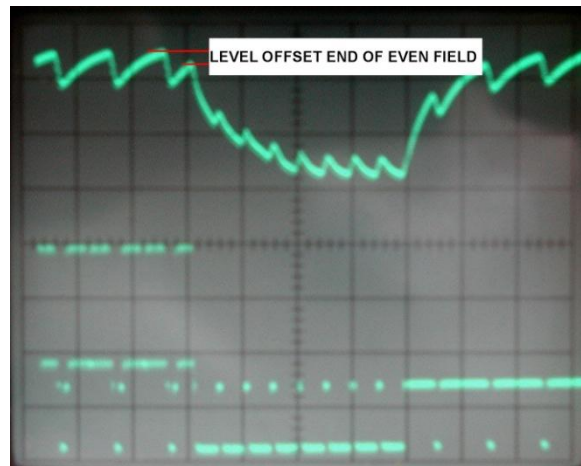
The reason for some of this error turned out to be in the sync separator stage. Due to the large value anode resistor 39k, combined with the 0.001uF capacitor, the integration of the composite sync was heavy enough that there was a different DC level on odd & even fields prior to the leading edge of the vertical sync pulse:

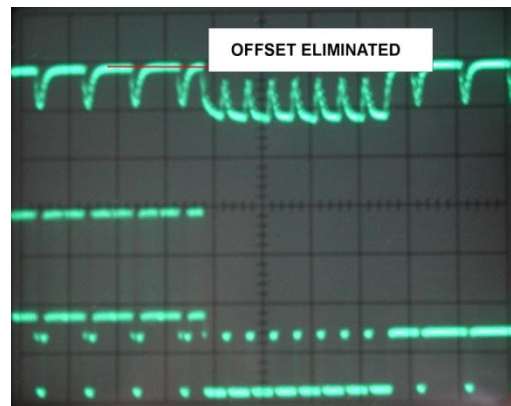
The fix was to parallel a 15k resistor with the 39k and lower the 0.001uF capacitor to 500pf, Then the voltage prior to the vertical sync is the same for both odd & even fields, because the now 500pF capacitor combined with the lower value of anode resistance charges up after the H pulse which is only half a line away from the vertical pulse at the end of the even field, to the same value as the end of the odd field, where the H pulse is a whole line away:

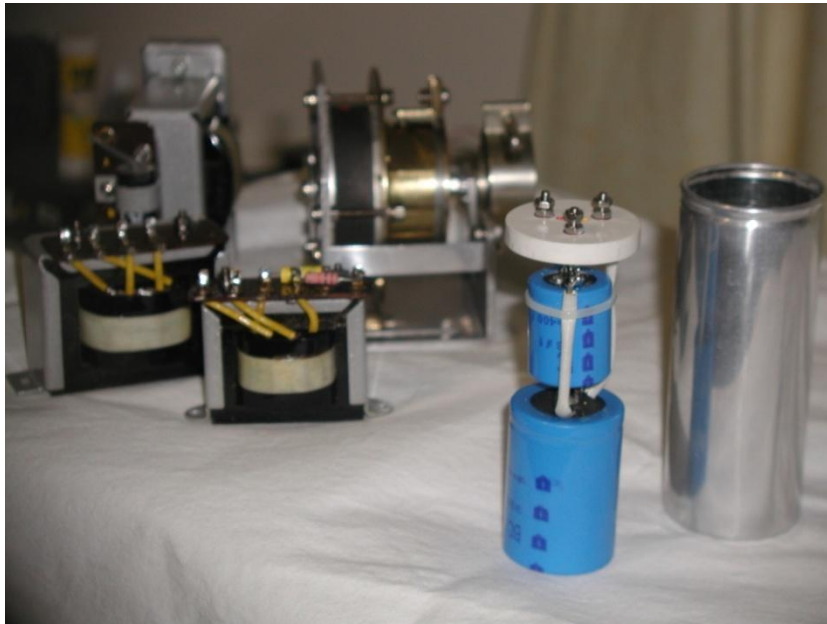
New Electrolytic Capacitors placed in old metal can. Transformers & chokes restored, the brackets were re-electroplated and painted to improve the appearance and protect them and the rusty laminations treated with Fertan and the transformers varnished:

The white material making the insulator/connection for the electrolytic is ¼ inch thick Bramite. Paxolin or 6mm thick fiberglass would also work. Notice how most of the lip on the large electrolytic's can is preserved. This is much better than cutting the aluminium can near its base, especially in this case where it is clamped near the other end in the set.
